### Section 2.7 Land Use

## Section 2.0 Existing Conditions

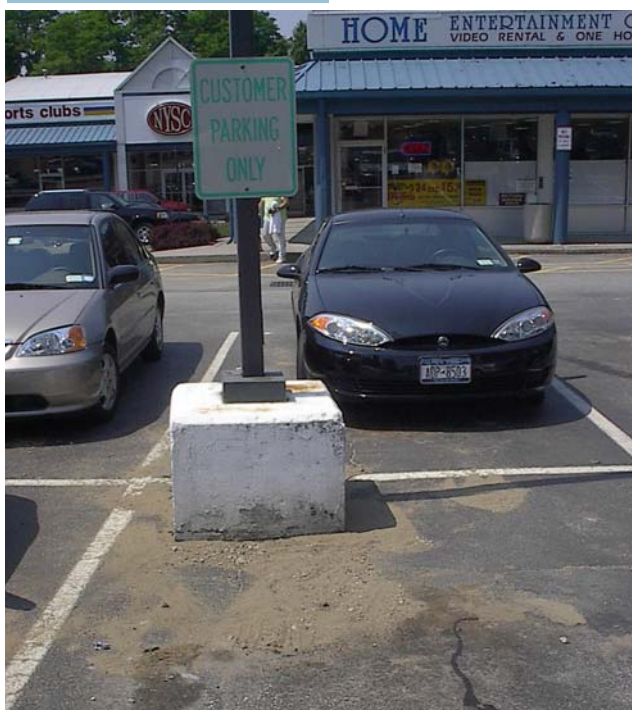
**Figure 2-33. Shop-Rite Plaza,  
Croton-on-Hudson,  
New York**

Commercial and transportation uses comprise approximately 16% of Croton. Although nonresidential land uses are a small percentage of the total land area in Croton, nonresidential land uses typically have large areas of impervious surfaces and onsite activities that could degrade water quality. If stormwater from these parcels is not properly controlled and treated, these parcels have the potential to contribute significant pollutants into watershed. Major areas of concern are the shopping center located behind 9/9-A, Metro-North train station and Route 9/9-A.

Stormwater problem area investigations were conducted in Croton using site reconnaissance techniques. Currently, all stormwater runoff from Route 9/9A drains directly from the roadways discharging into Croton Bay. The Shop Rite Shopping Center, located on Riverside Avenue, has a large parking lot with little pervious surface. Sediments can be found throughout the parking lot that directly drain into
